**DEPARTMENT OF TRANSPORTATION**

Contract #: 04-0120F4Cty: SF/ALA Rte: 80 PM: 13.2/13.9File #: 69.28**WELDING INSPECTION REPORT****Resident Engineer:**Pursell, Gary**Address:** 333 Burma Road**City:** Oakland, CA 94607**Report No:** WIR-015072**Date Inspected:** 18-Jun-2010**Project Name:** SAS Superstructure**OSM Arrival Time:** 700**Prime Contractor:** American Bridge/Fluor Enterprises, a JV**OSM Departure Time:** 1900**Contractor:** Zhenhua Port Machinery Company, Ltd (ZPMC), Changxing Island **Location:** Shanghai, China**CWI Name:****CWI Present:****Yes No****Inspected CWI report:** **Yes No N/A****Rod Oven in Use:** **Yes No N/A****Electrode to specification:** **Yes No N/A****Weld Procedures Followed:** **Yes No N/A****Qualified Welders:** **Yes No N/A****Verified Joint Fit-up:** **Yes No N/A****Approved Drawings:** **Yes No N/A****Approved WPS:** **Yes No N/A****Delayed / Cancelled:** **Yes No N/A****Bridge No:** 34-0006**Component:** OBG Trial Assembly**Summary of Items Observed:**

## WELDING INSPECTION REPORT

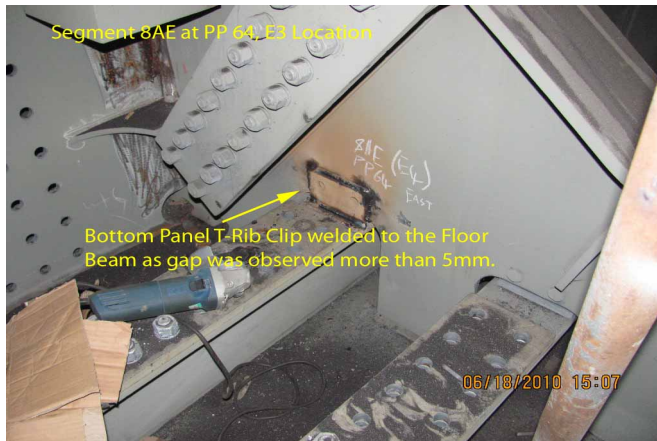
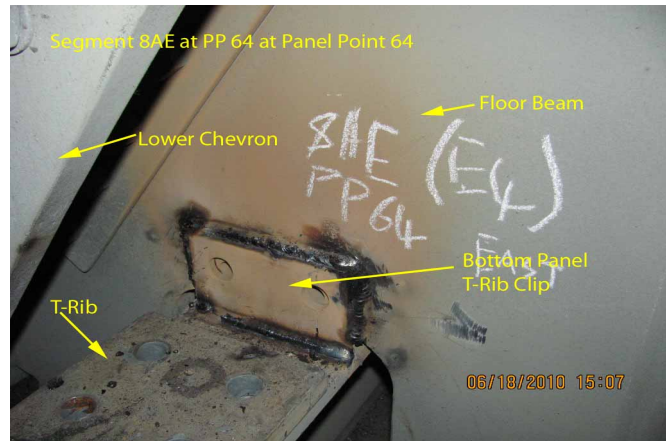
This QA Inspector observed during random visual Inspection at Segment 8AE at PP 65 at Work Point E3, East side of the Floor Beam that Bottom Panel T-Rib Clip is been welded to Floor Beam as gap between the faying surface was observed as 5mm. The work is been performed against the ABF RFI # ABF-RFI-001758R00 Dated May 19, 2009.

Please refer the attached pictures for more comprehensive details.
